Rockwall Home Inspections

PROPERTY INSPECTION REPORT

Concerning: Rockwall, TX 7032
(Address or Other Identification of Inspected Property)

By: Uriah Shockley TREC # 9413 06/26/2013
(Name and License Number of Inspector) (Date)

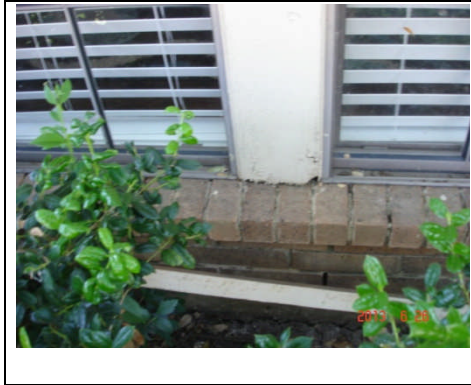
Signs of water penetration into walls from window ceils along with rotted trim around windows. Fix or repair.

Signs of water penetration into walls with rotted wood painted over inside and out; observed in dining room at window ceil. Fix or repair

Rotted siding at dining room window

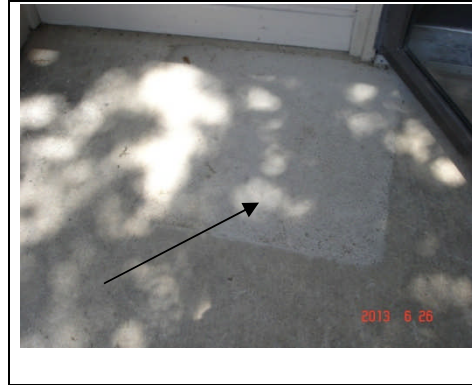
Evidence of past foundation repairs at left side of unit and at patio. Buyer should request a copy of structural engineers report and foundation repair report and have them evaluated by a, 3rd party structural engineer, to assure that remedies for repair are appropriate and have been carried out in a proper fashion by the foundation repair company.

- K. Porches, Balconies, Decks, and Carports** *Comments:* Evidence of foundation repair at back patio.

Repair spot where pier was installed at patio.

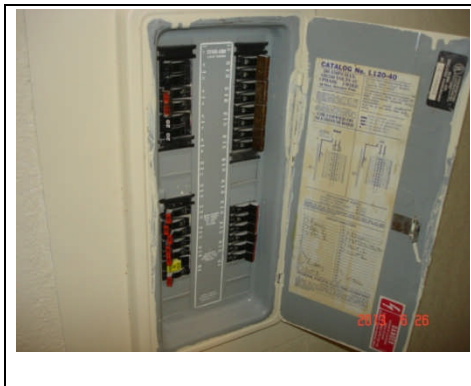
Main Breaker panel is a federal Pacific Sab-Lok, panel. This panel has lost its listing by Underwriters Laboratories due to a long list of deficiencies such as explosions, fires, breakers fall out when removing panel, electrocutions, staying on when turned off, failure to trip...and many other deficiencies. It is highly recommended that the current breaker panel be replaced with a more reliable breaker panel that meets Underwriters Laboratories approval for commercial and residential use.

Today's standards do not allow panels in bathroom unless it is in a closet. Recommend a qualified, current licensed master electrician, evaluate condition and remedies for repair.

FPE stab-Lok installed in bathroom

- A. Service Entrance and Panels** *Comments:* Inspector deemed it unsafe to remove panel since it was a FPE, Stab-lok panel. Buyer should have a qualified, current licensed electrician remove FPE breaker panel to examine that there are no spliced wires inside panel, general condition of breakers and wires.

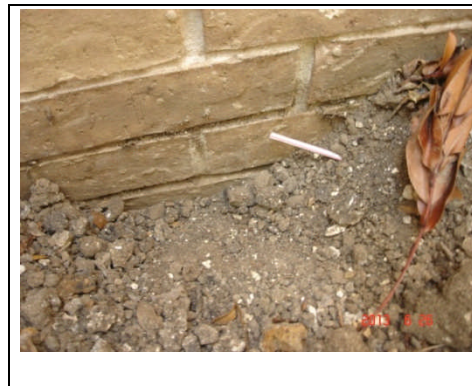
B. Grading & Drainage *Comments:* Soil is 4" inches over foundation wall at left rear side of structure where piers are suspected to be installed. This can cause water to enter exterior walls causing rot, attract termites and eventually structural damage to wood support studs and base plates if left uncorrected. Fix of repair. Most likely a HOA issue.

Soil 4 inches or more above foundation wall.

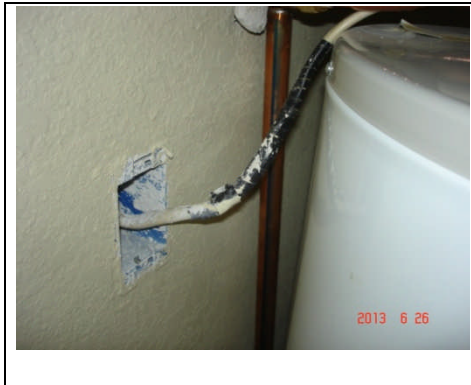
220 wires for water heater are improperly spliced outside of a junction box. Fix or repair.

220 wires improperly spliced outside of junction box.

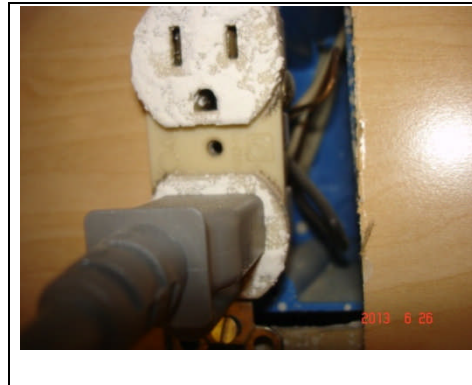
An extensive amount of loose plug outlets throughout condo was observed by inspector. Outlets should be examined by a current licensed electrician and repaired as needed.

One of several plugs not secured and covered.
