Inspection Photos

[Job ID: 1115-0559-09]

Images for Week Ending: 10/15/11

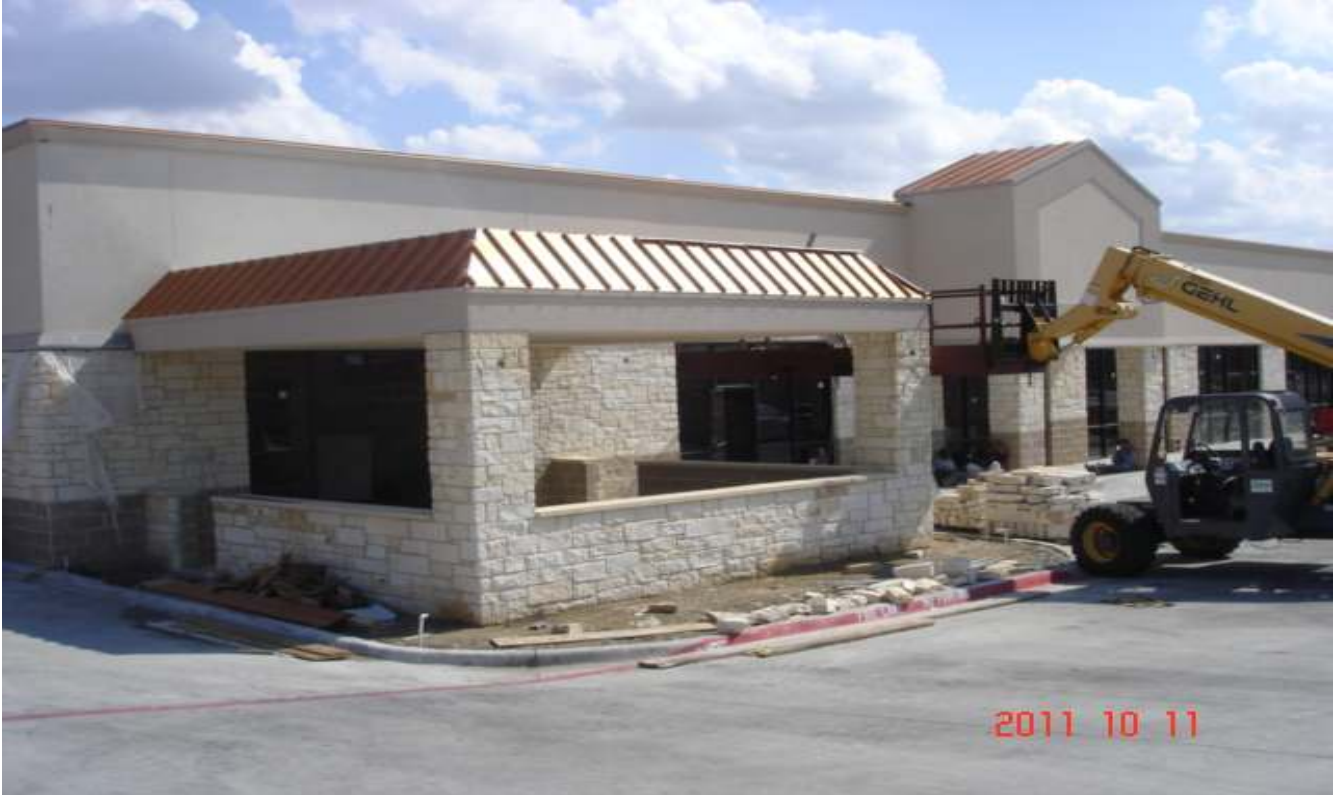
1

Some pick up sheet metal roofing installation was ongoing for the patio mansard. Stone veneer and stucco are completed. Landscape around the building is needed.

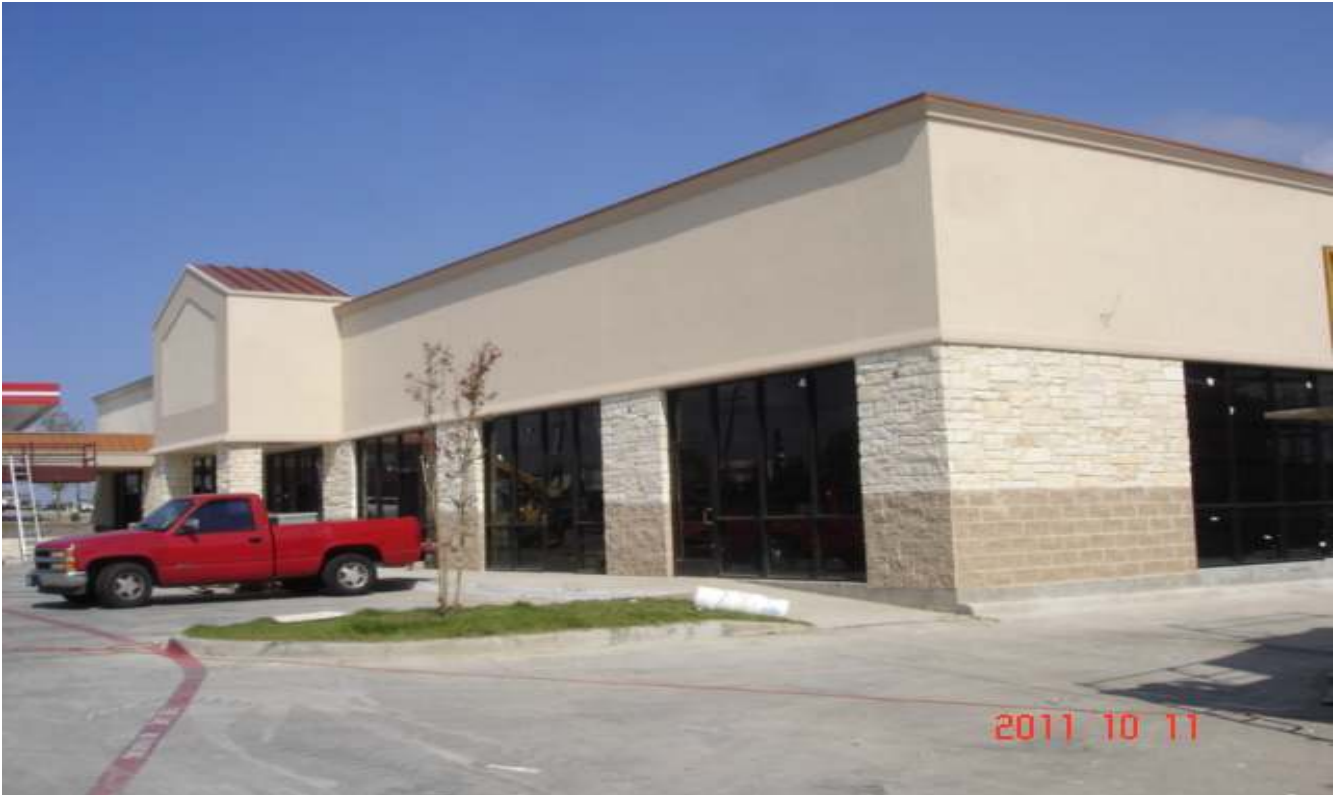
2

Pro panel steel roofing installation for the entry tower is completed. Roof cornice trim has been installed. Site concrete is installed. Landscape in the islands is completed for this area. Storefront windows and doors have been installed.

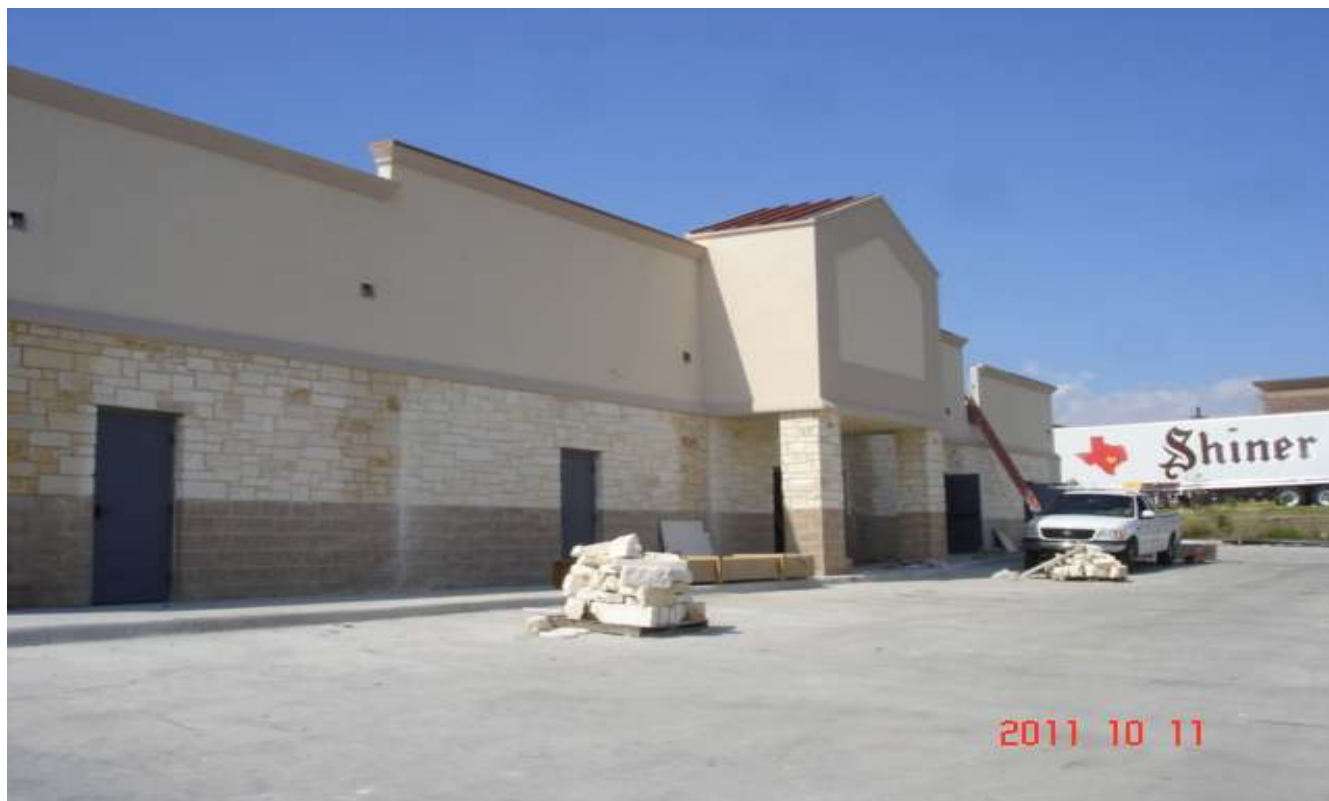
3

Light fixtures are needed in the openings at the back and side of the building. Stucco and veneer installation has been completed. Steel man doors have been installed and they need to be painted.

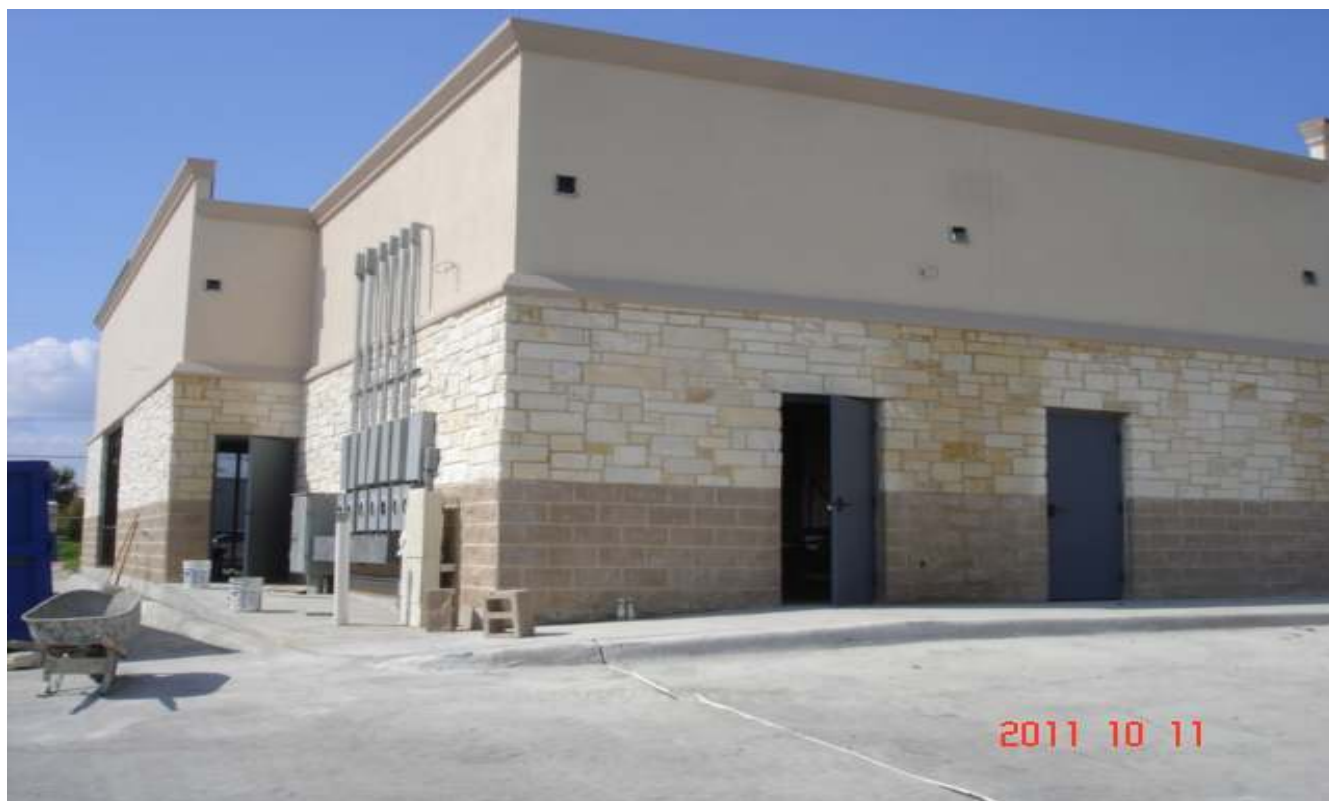
4

Individual electrical panels for all units have been installed. Protection bollards have been installed.

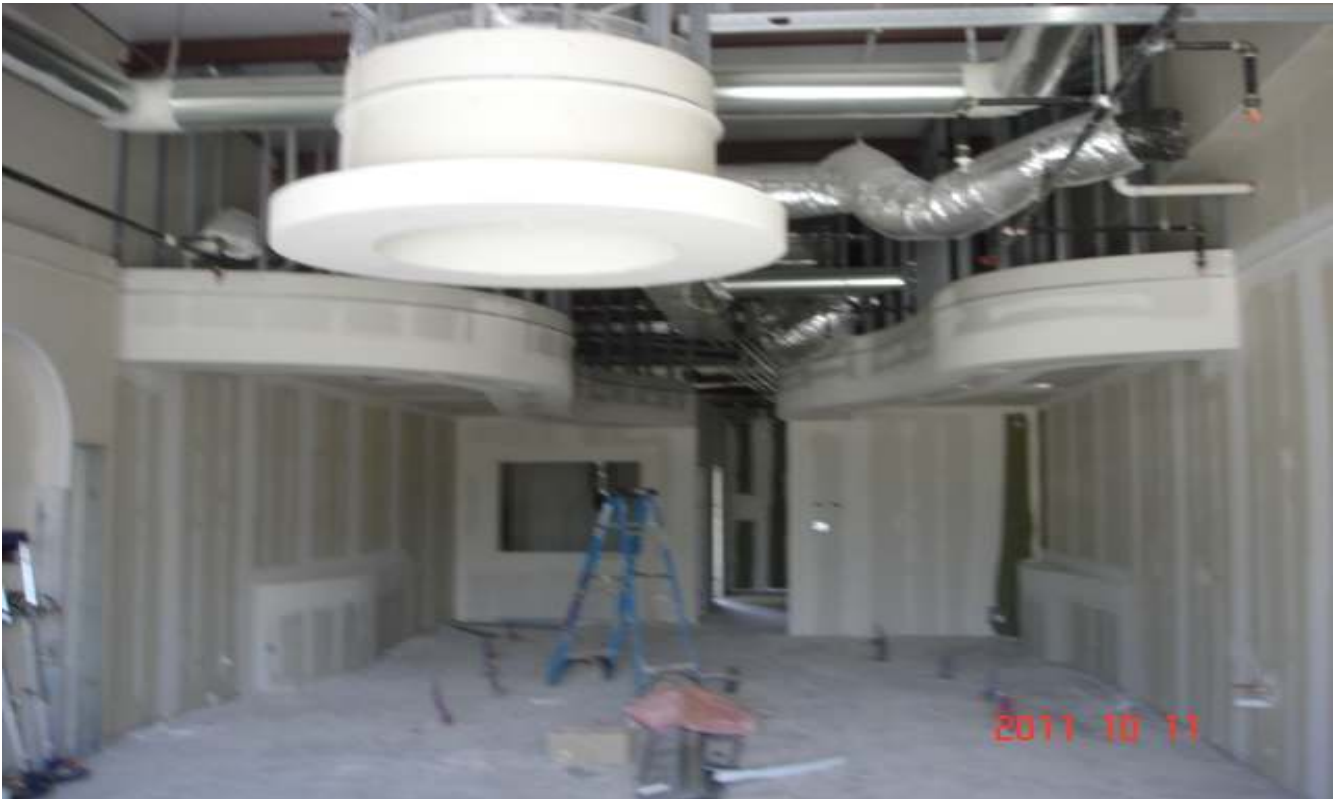
5

Drywall has been hung and taping was nearing completion for the nail salon. All rough ins are completed. Acoustical ceiling installation has not begun. Painting is needed.

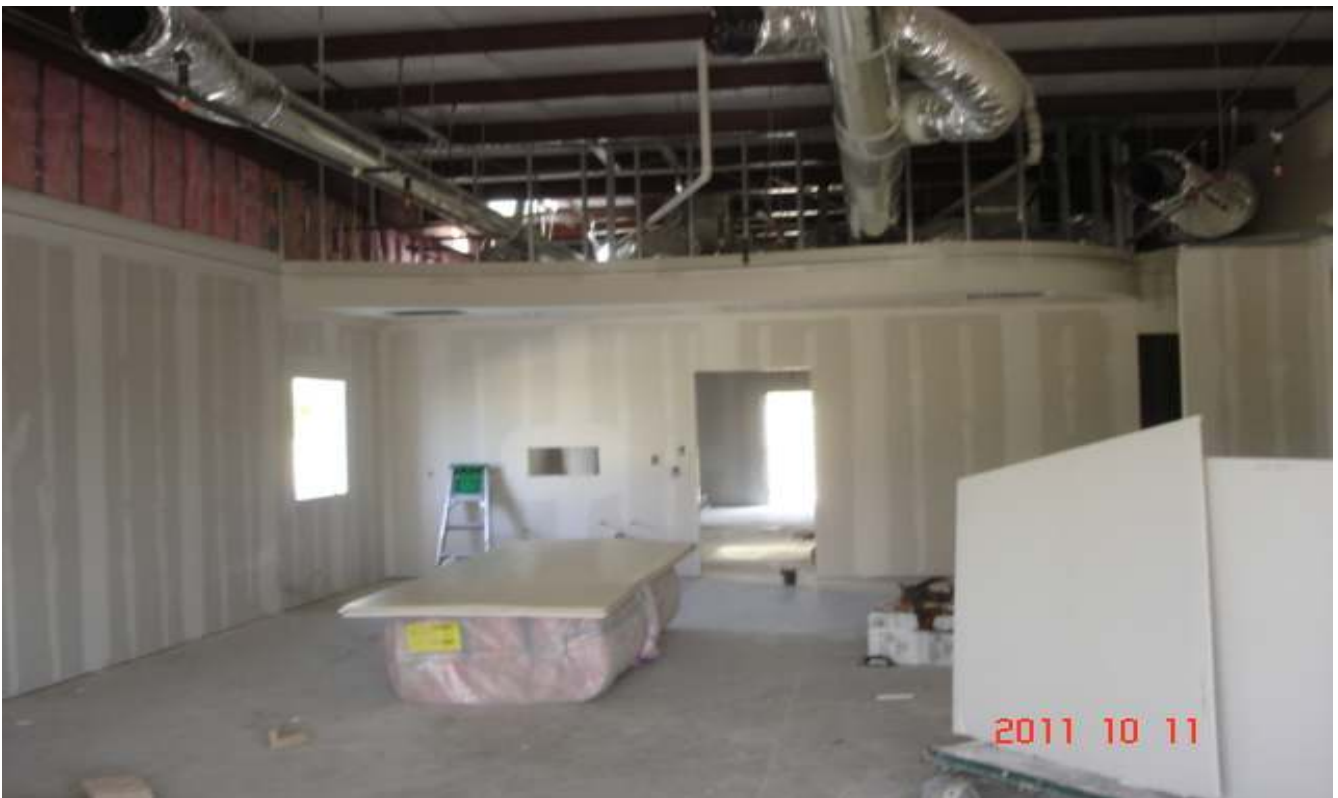
6

Drywall taping is nearing completion for the sandwich shop. All rough ins are completed. Acoustical ceiling and painting are needed. There is a jacuzzi tub stocked in the middle of the restaurant.

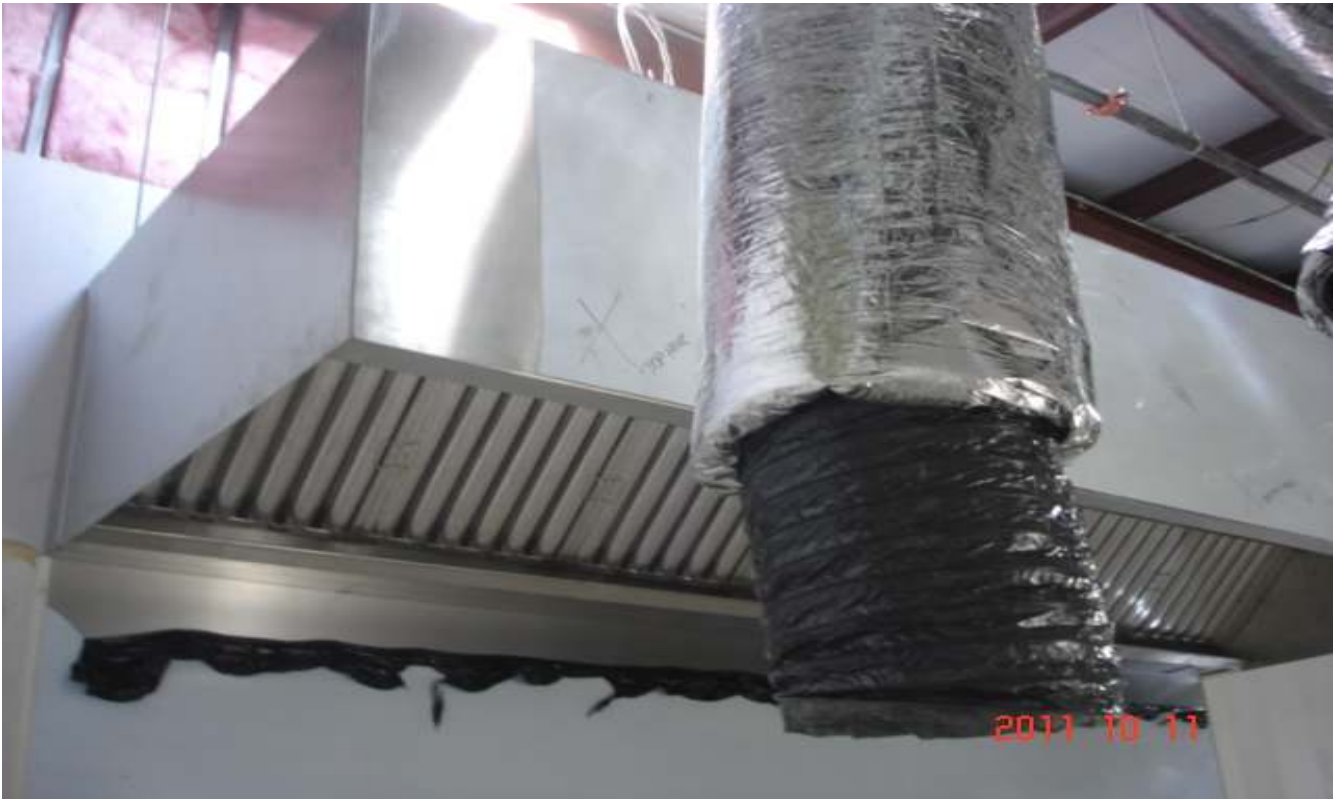
7

Vent hood for the restaurant is installed. Finish installation of the HVAC ducting will take place after the acoustical ceiling grid is installed. Fire sprinkler installation is completed.

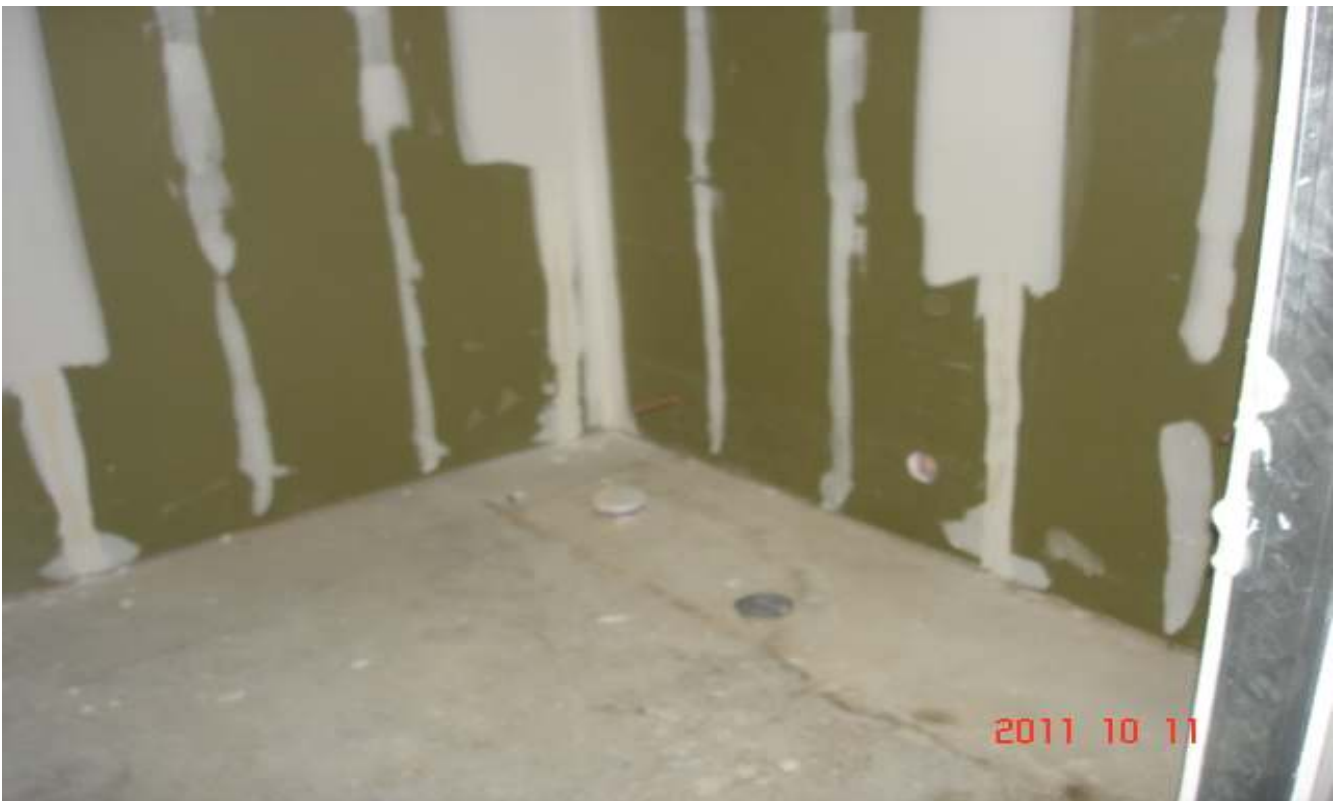
8

No interior finishes have started for the bathrooms in the restaurant. No interior doors have been hung. Painting is needed.

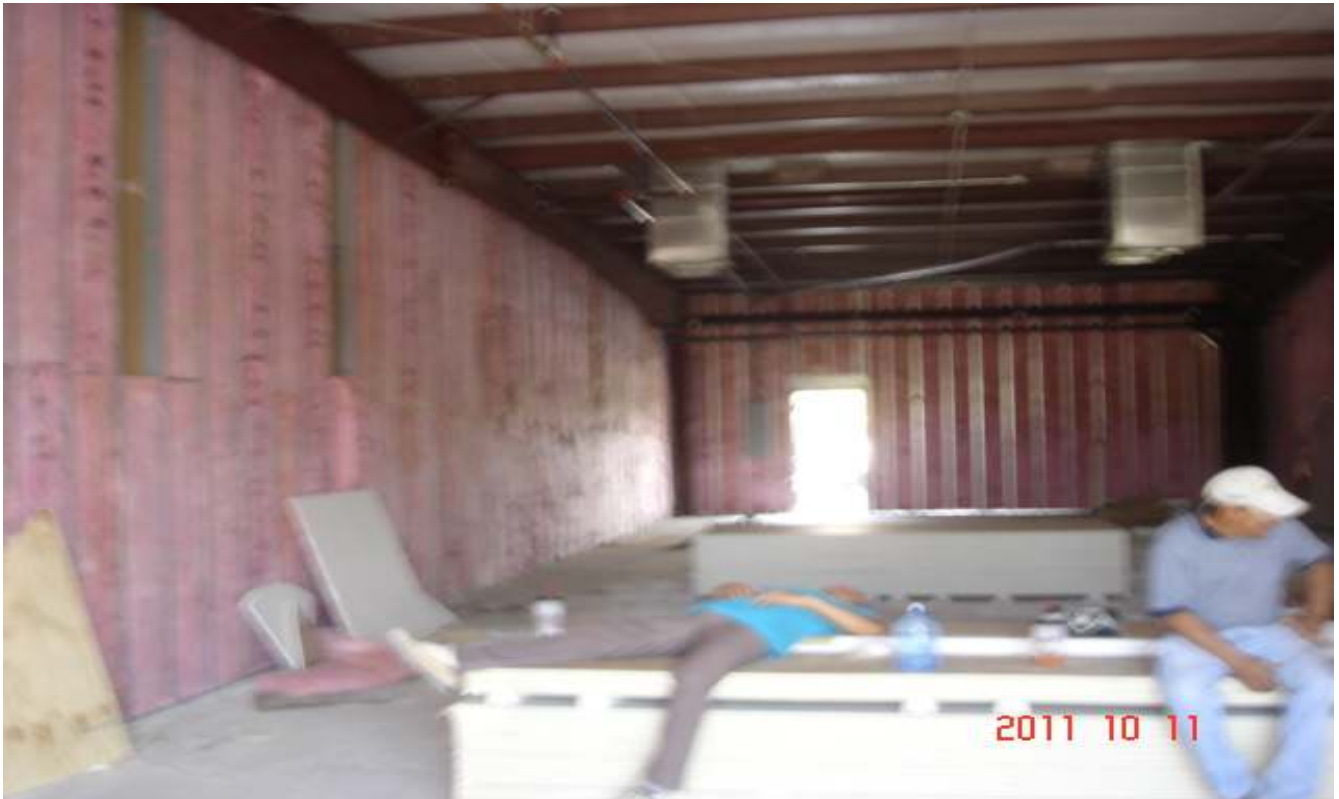
9

Insulation has been installed for the demising walls in this typical unit that has not been leased. Drywall is stocked for installation on the demising walls. All shell rough ins have been completed.

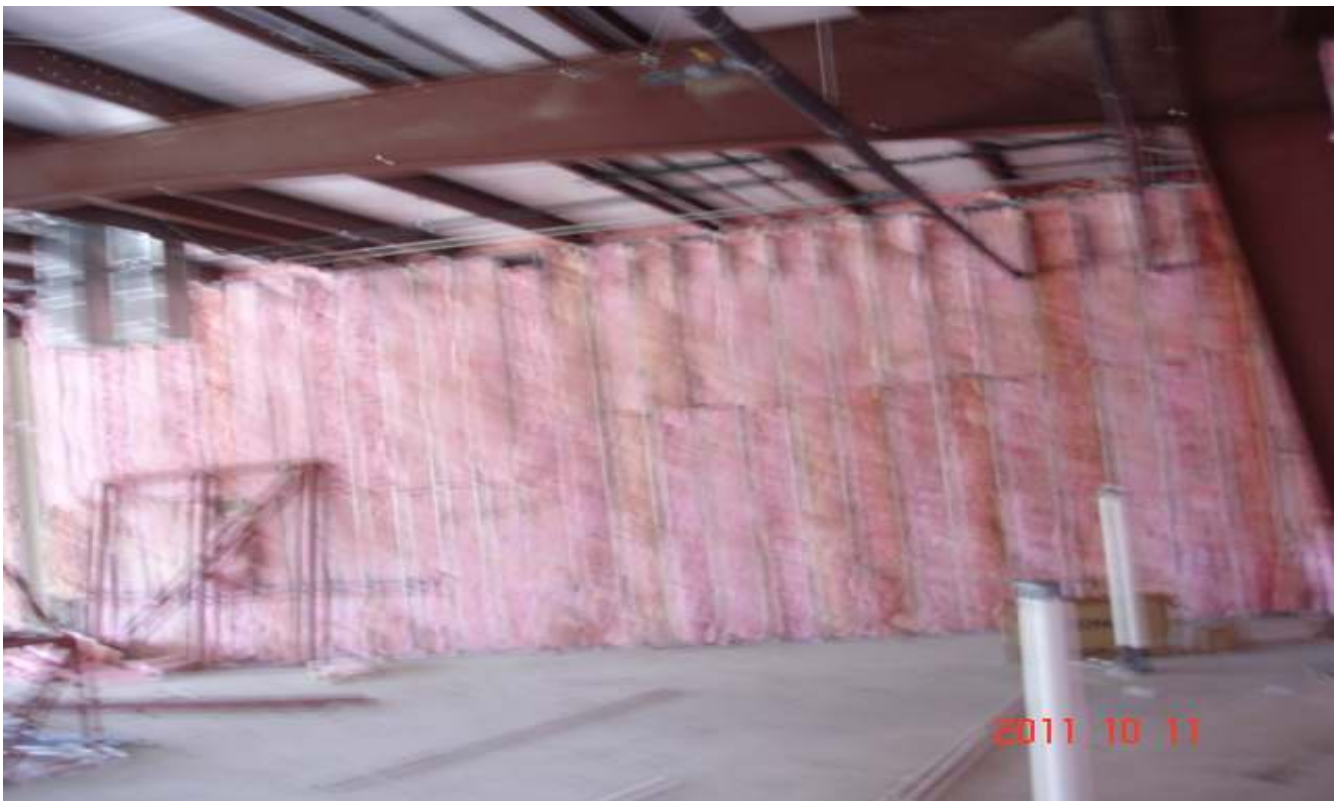
10

Installation of insulation is nearing completion on all unleased units.

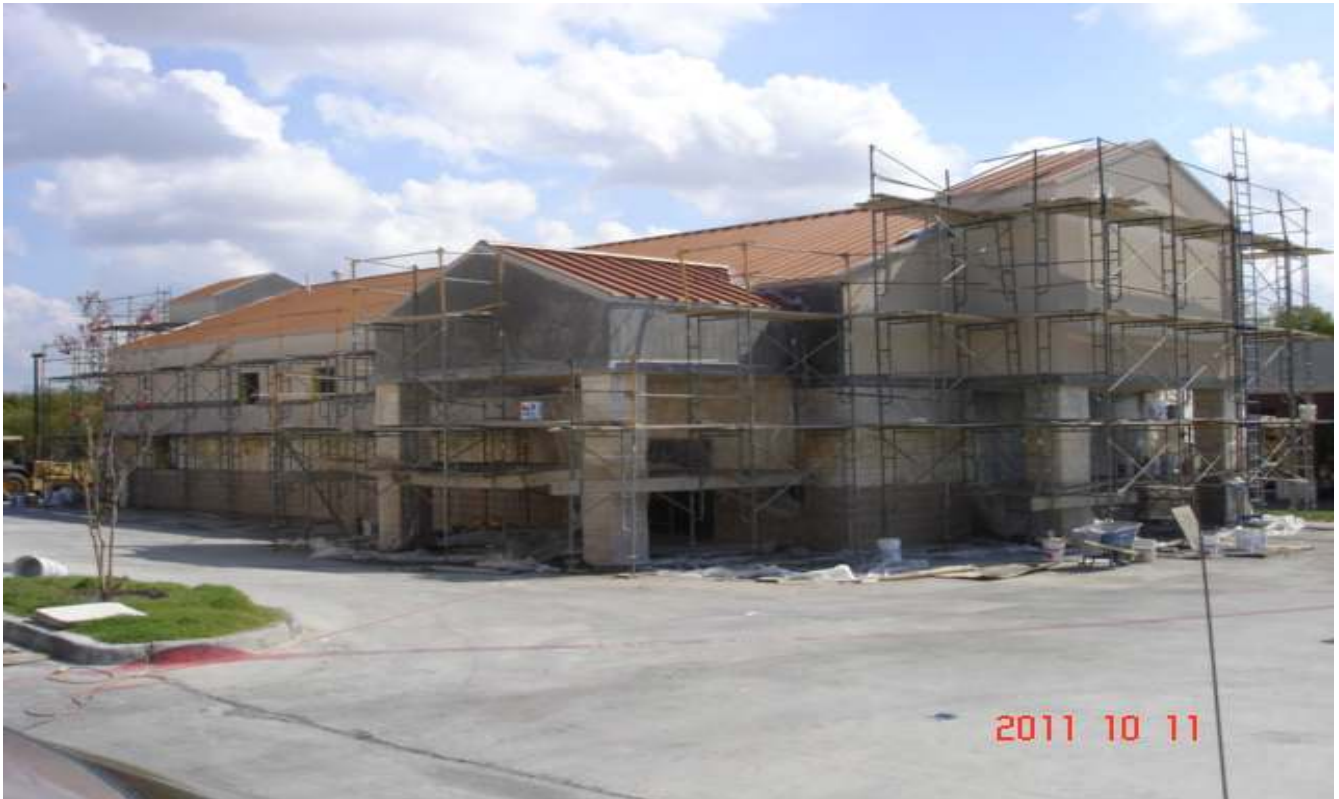
11

Stone veneer has been completed for the laundry building. Stucco color coat is ongoing. Pro panel sheet metal roofing has been installed. Scaffolding is erected for the completion of the stucco process.

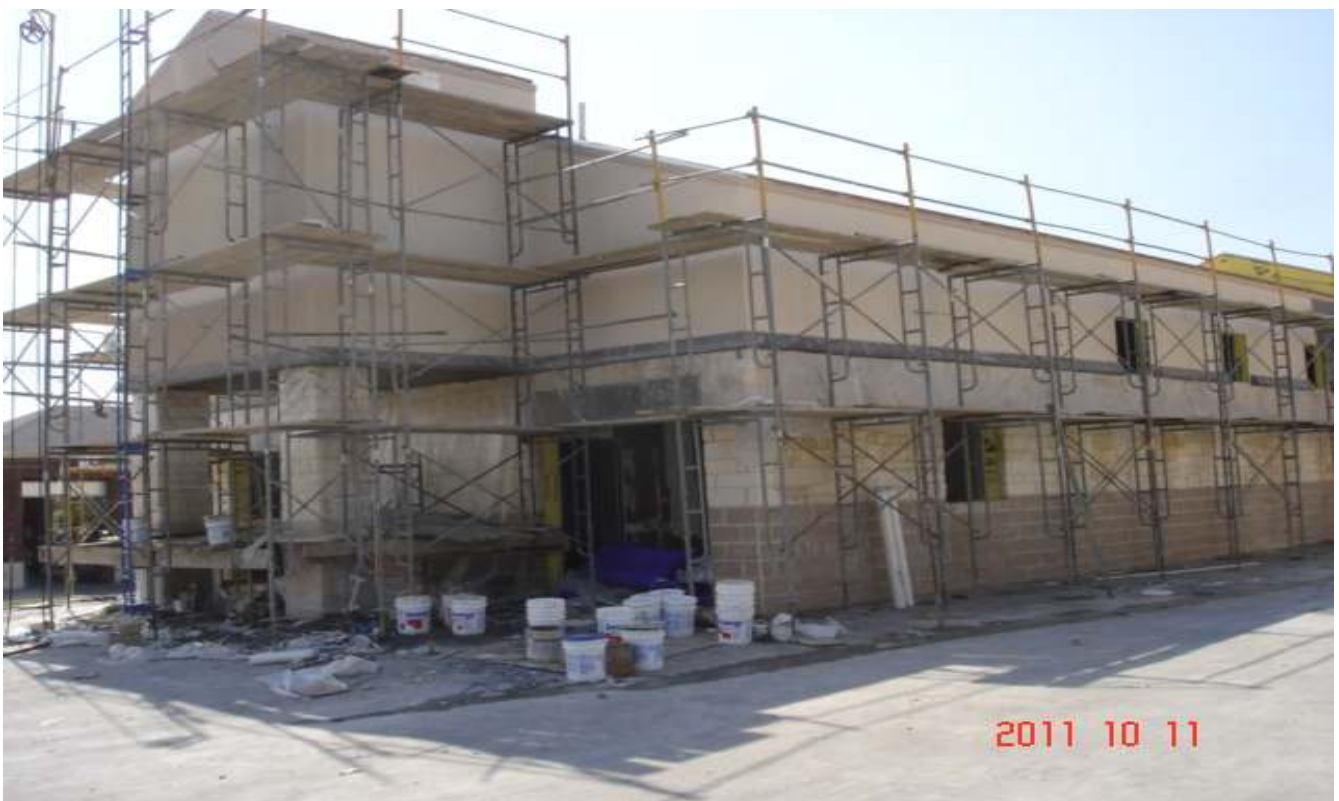
12

This is another view of the side of the building. Stucco process is nearing completion.

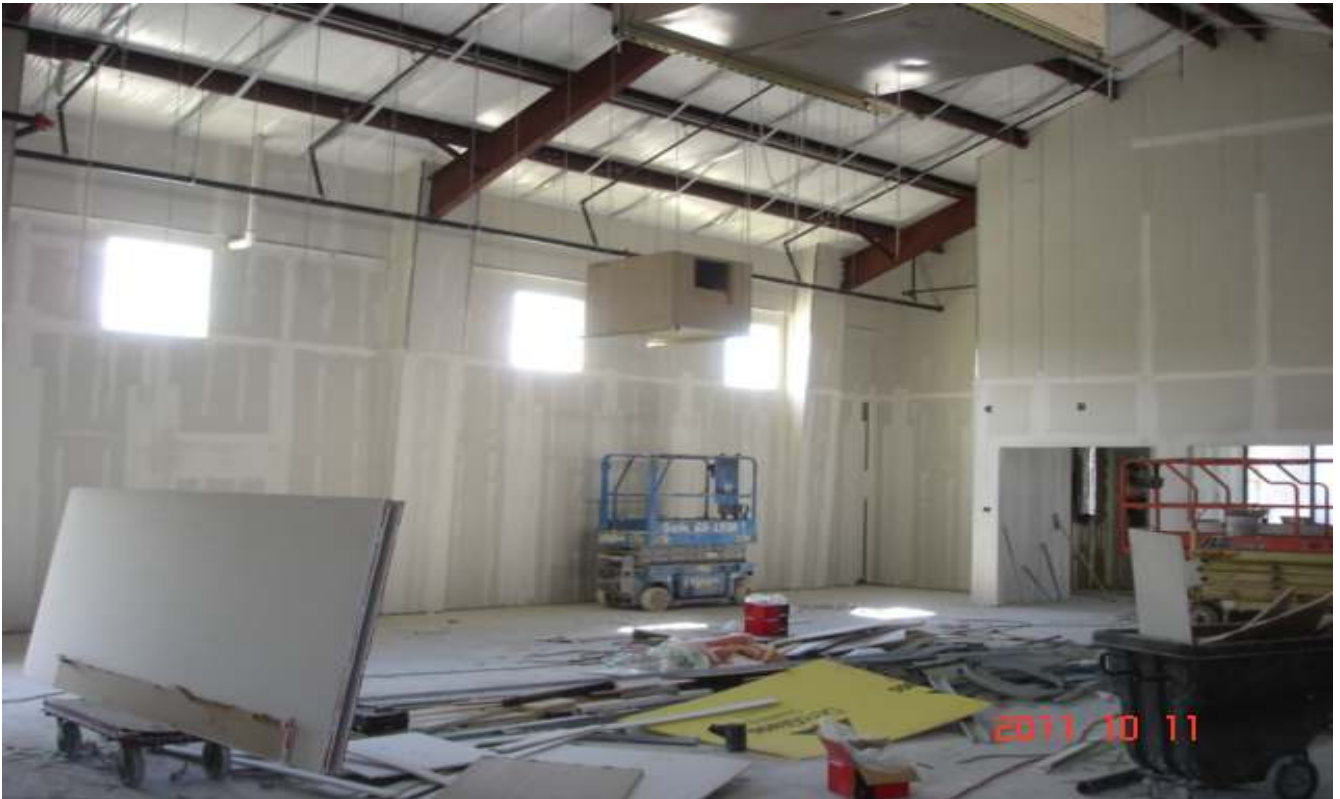
13

Drywall taping is nearing completion on the interior of the laundry building. Fire sprinkler installation is completed. HVAC units were being installed. These units are being hung from the ceiling.

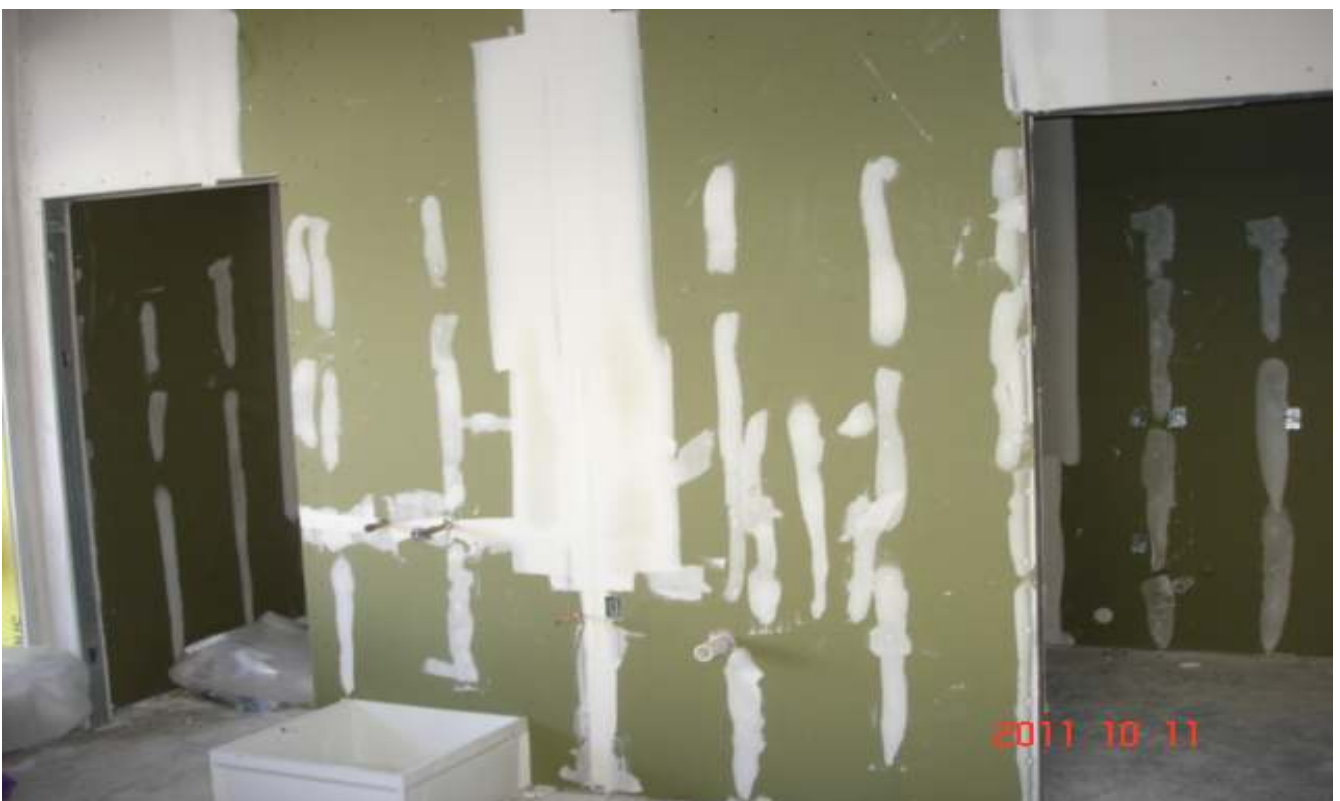
14

No finishes have started for the rest-rooms in the laundry building. Drywall taping is nearing completion.

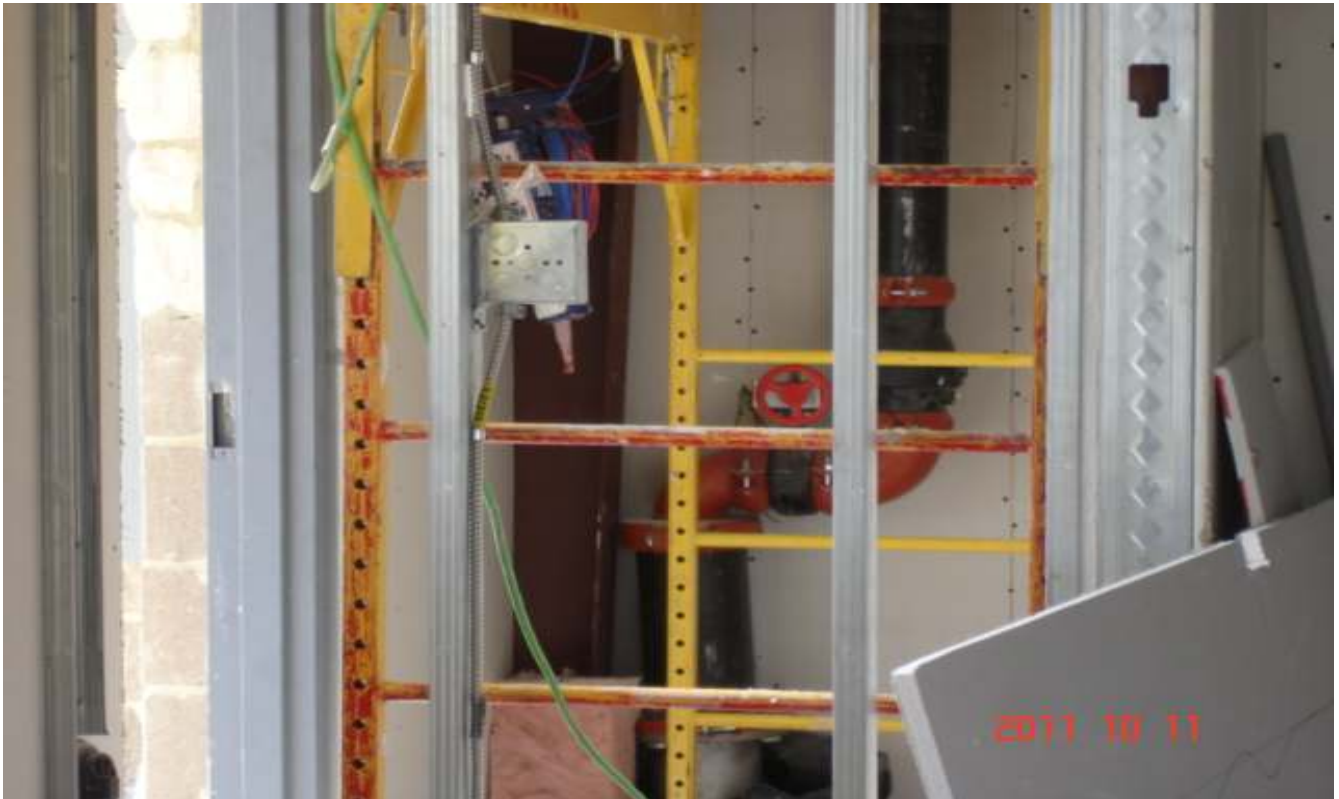
15

Fire sprinkler valve system has been installed.

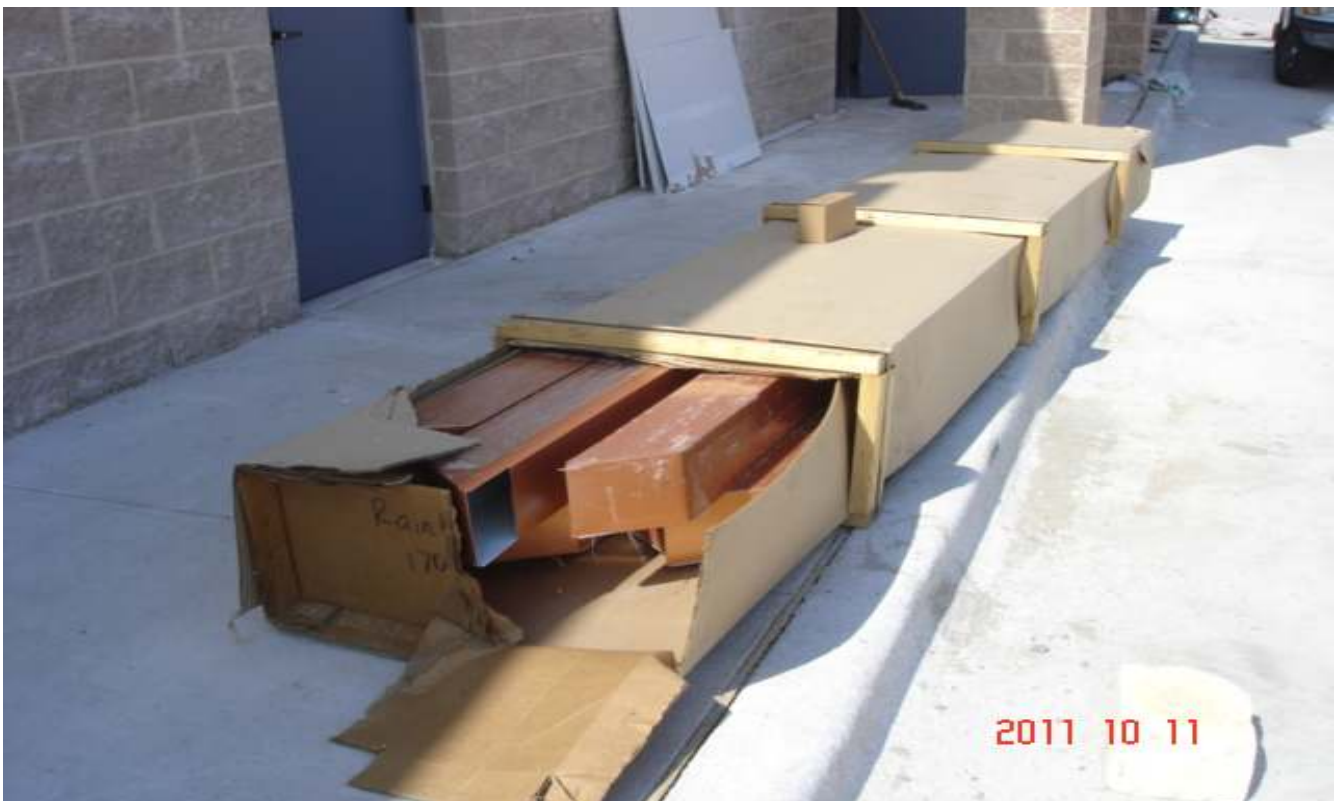
16

Gutters are stocked on site awaiting installation.

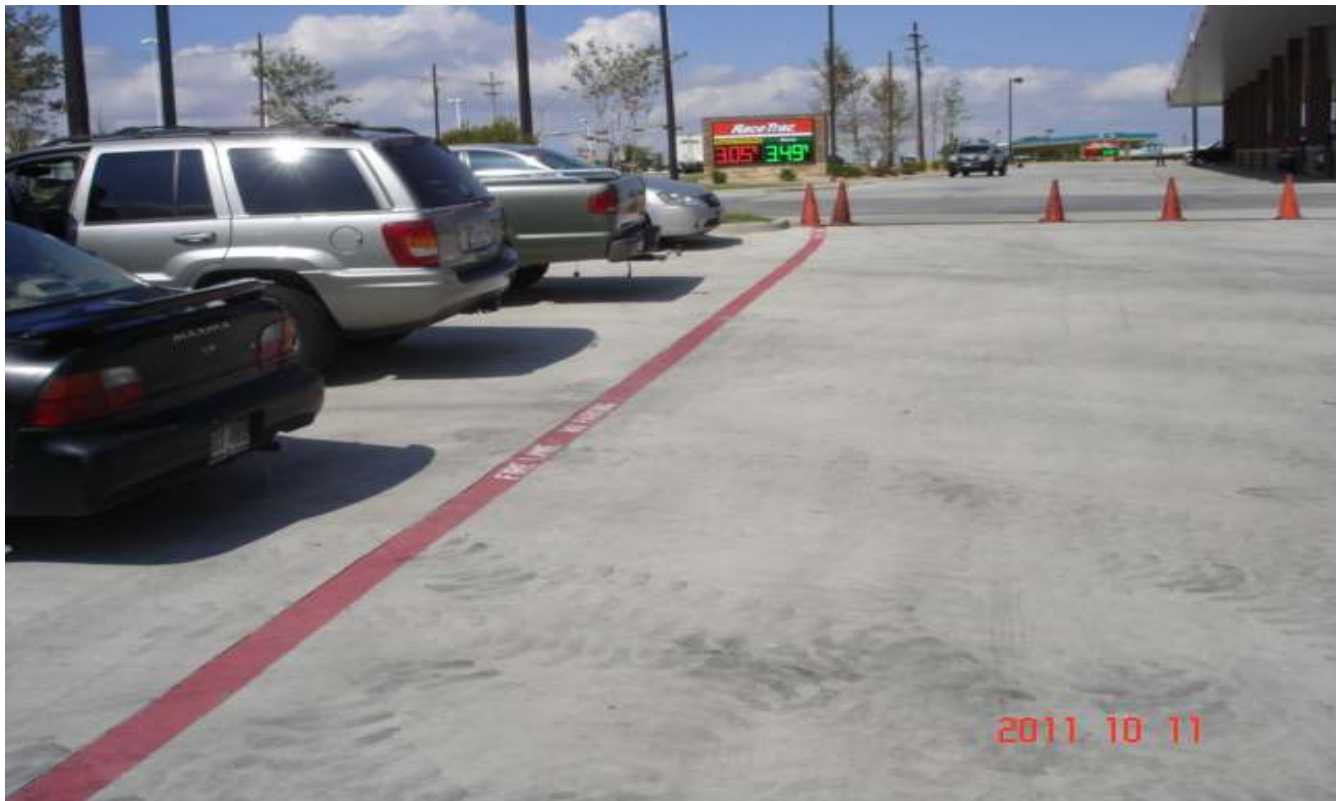
17

Final striping and handicapped signage has not started for the parking lot.
