## PROPERTY INSPECTION REPORT

**Concerning:** Anywhere, Rockwall, TX 75032

**By:** Uriah Shockley TREC # 9413

02/04/2013

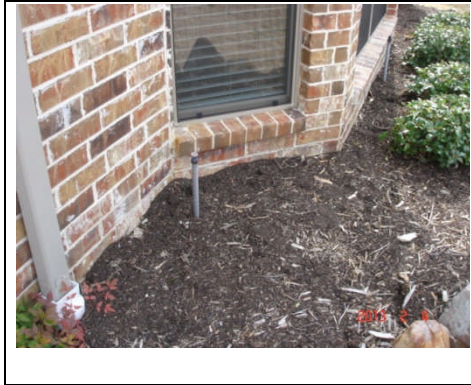
**B. Grading & Drainage** *Comments:* Mulch height should be lowered so that weep holes can breath and foundation walls can be monitored for pests and wood destroying insects.

Mulch needs to be lowered around foundation.

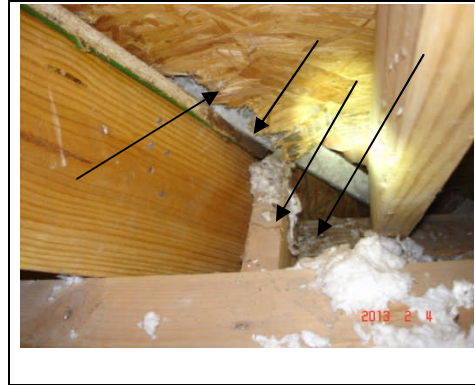
It was observed from the attic and at roof top that the roof is leaking over the office next to flashing with damaged roof top decking warranting further investigation and remedies for repair by a current licensed building contractor or qualified roofer to prevent storm water from entering exterior walls and/or structure. Fix or repair.

It was observed from the attic and at roof top that the roof is leaking over the office next to flashing with damaged roof top decking warrants further investigation and remedies for repair by a current licensed building contractor or qualified roofer to prevent storm water from entering exterior walls and/or structure. Fix or repair.

Damaged roof decking over office with evidence of water in attic

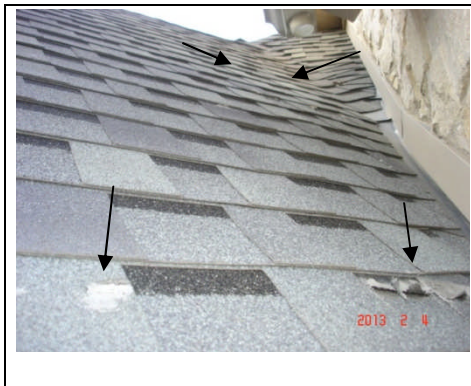
Roof material over front office has several damaged shingles that should be examined and replaced as needed.

Damaged shingles over office

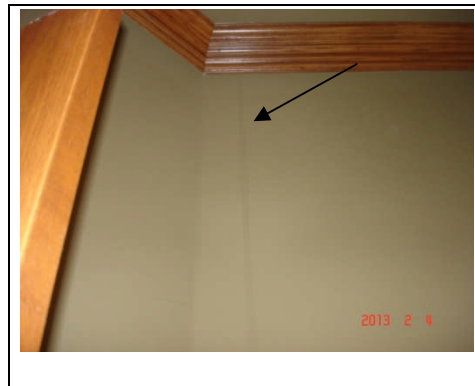
**E. Walls (Interior & Exterior)** *Comments:* Water stain observed front office interior wall due to roof leak. Fix or repair with paint.

Water stain in office directly below damaged decking

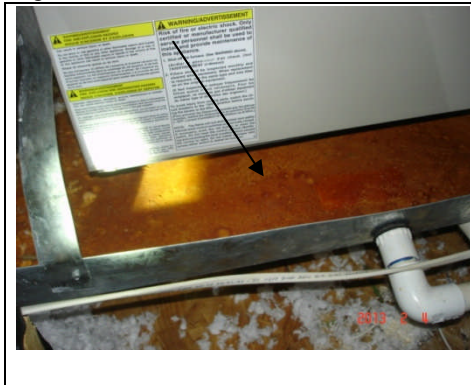
AC attic unit for master bedroom has rust in the secondary drip pan indicative of a clogged primary drip pan. Fix or repair by a current licensed HV/AC professional.

AC attic unit for main living area has extreme rust in the secondary drip pan and is staining the roof indicative of a clogged primary drip pan. Fix or repair by a current licensed HV/AC professional.

Evidence of clogged primary drip lines.

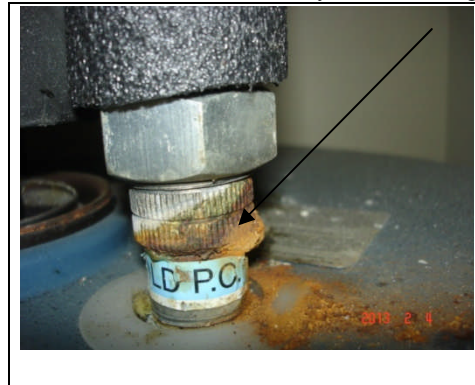
**C. Water Heating Equipment**  
*Energy Source:* Gas  
*Capacity:* 2 units, 50 gls each  
*Comments:* Corrosion at base of water supply line on water heater #1, should be repaired before imminent failure. Fix or repair.

Water supply connection for water heater, corroded.
