**Sample-Commercial Report
Rockwall Home Inspections
Rockwall, Texas 75087**

PROPERTY INSPECTION REPORT

Concerning: Anywhere, Rockwall, Tx 75087
(Address or Other Identification of Inspected Property)

By: Uriah Shockley TREC # 9413 05/31/2012
(Name and License Number of Inspector) (Date)

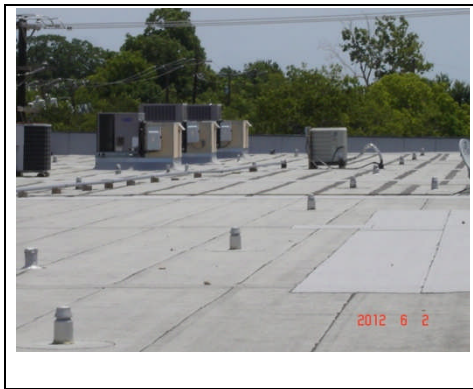
- C. Roof Covering Materials**
Type(s) of Roof Covering: Flat / low Slope roof with asphalt rolled roofing material
Viewed From: Inspected from drip edge with ladder to prevent any accidental damage to roof.
Comments: Performing as intended. Roofing material is considered to be in good condition. Past routine maintenance and repairs was observed as typical of roofs of similar construction.

Roof in good condition with maintenance repairs

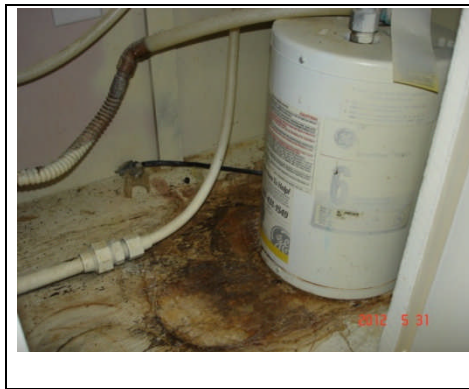
Comments: Water stains under kitchen sink and water damaged wood, Source of water undetermined.

Comments: Under kitchen cabinet water heater is rusted and near or exceeded average life expectancy. Unit should be replaced before it fails.

old water heater rusted and water stains under sink

Water heater is missing drip pan and drip line. Fix or repair.

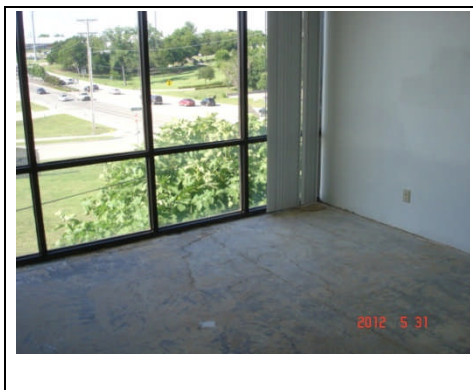
Bare floors

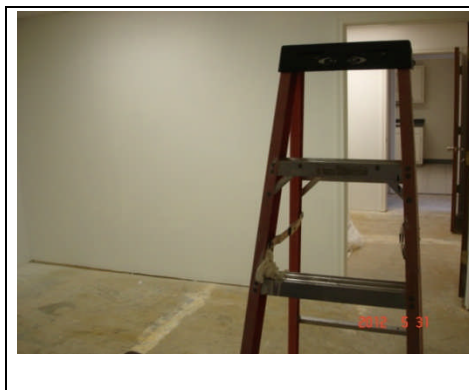
Interior Walls: Partition walls with sheet rock, texture and paint are in the process of being installed along with floor molding and other trim..

partition walls installed being painted.

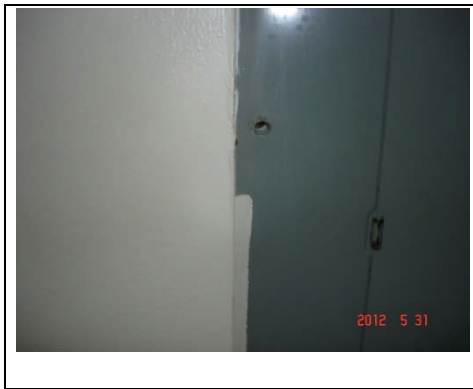
Breaker panel in kitchen is missing specialized flat head panel screw. Fix or repair

Fastener missing on breaker panel.
